Appendix I4

Biological Opinion & Biological Assessment

Consultation Number: 02ETAU00-2015-F-0031

RE: CSJs 0253-04-138 & 0253-04-146

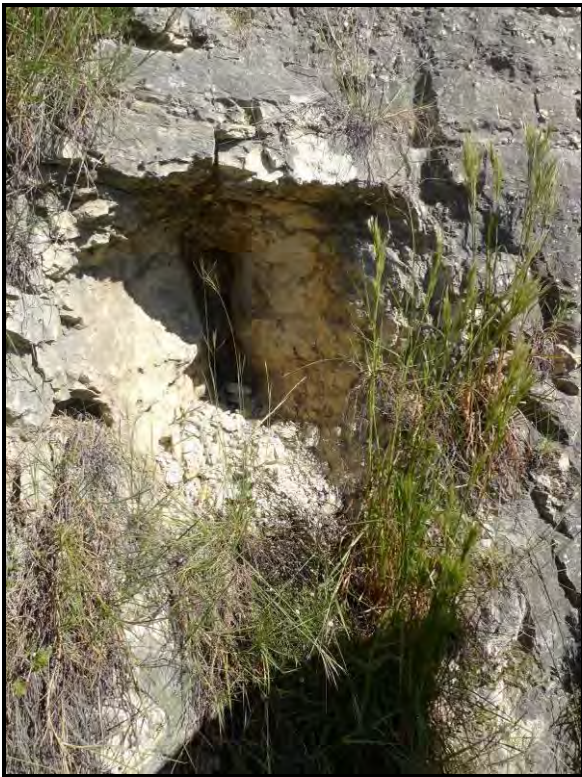
281-096, solution cavity/enlarged fracture This enlarged fracture is situated in the eastern road cut of US 281. It is 1 m (3.3 ft) wide, 1.2 m (3.9 ft) tall, and it extends into the road cut for 1.5 m (4.9 ft) (Figure 173). It contains some gravel infill that may be associated with construction excavation activities (Figure 174). This feature was not recommended for excavation (Table 1).

Figure 173. Overview of feature 281-096.

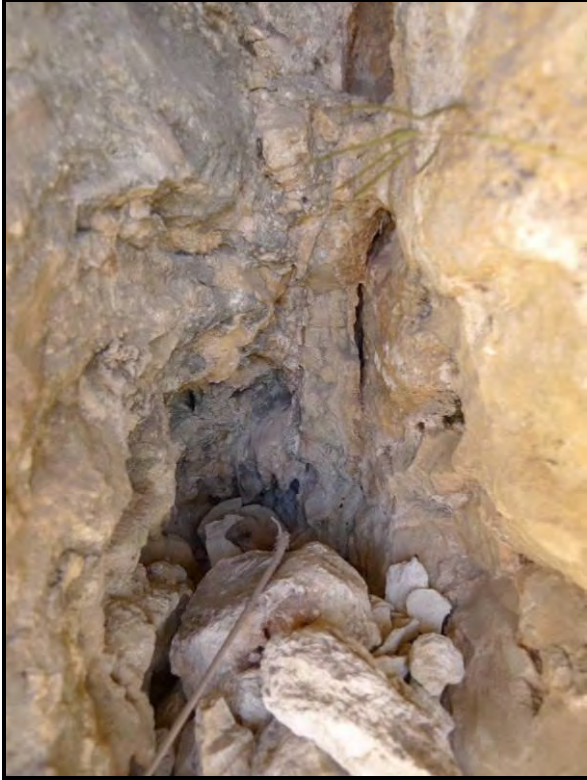
Figure 174. Interior of feature 281-096.

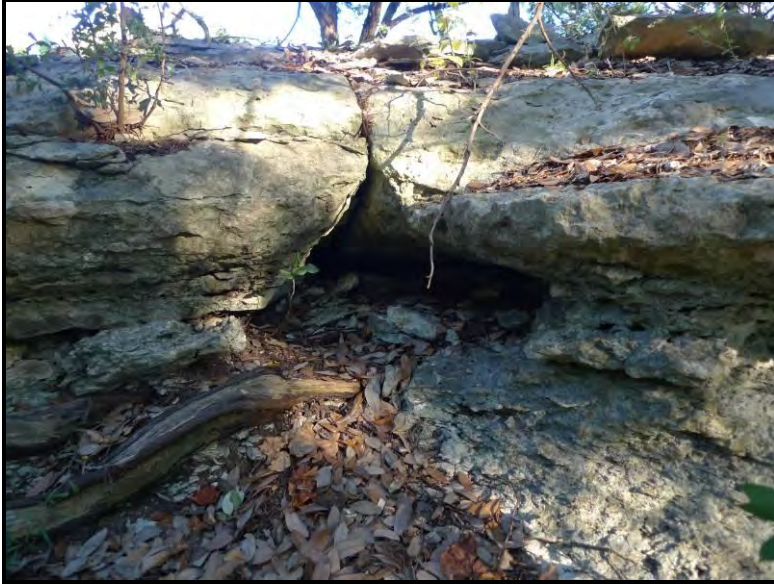
281-098, solution cavity/enlarged bedding plane This feature is an enlarged bedding plane on a creek bank (Figure 175). The entrance is 0.75 m (2.5 ft) wide, 0.3 m (1 ft) tall, and it extends into the creek bank for 1.6 m (5.2 ft). A fracture is present in the feature that trends at approximately 150 degrees. It has a coarse infill of rocks (Figure 176). The roof of the feature is only about 0.5 m (4.9 ft) thick, and is in the process of being eroded away due to proximity to the creek, and this feature is a result of that process. This feature was not recommended for excavation (Table 1).

Figure 175. Overview of feature 281-098.

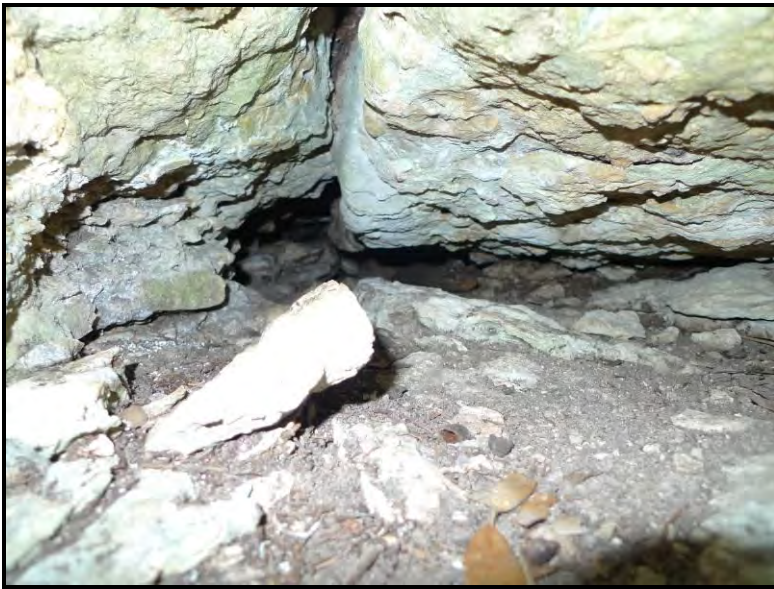
Figure 176. Interior of feature 281-098.

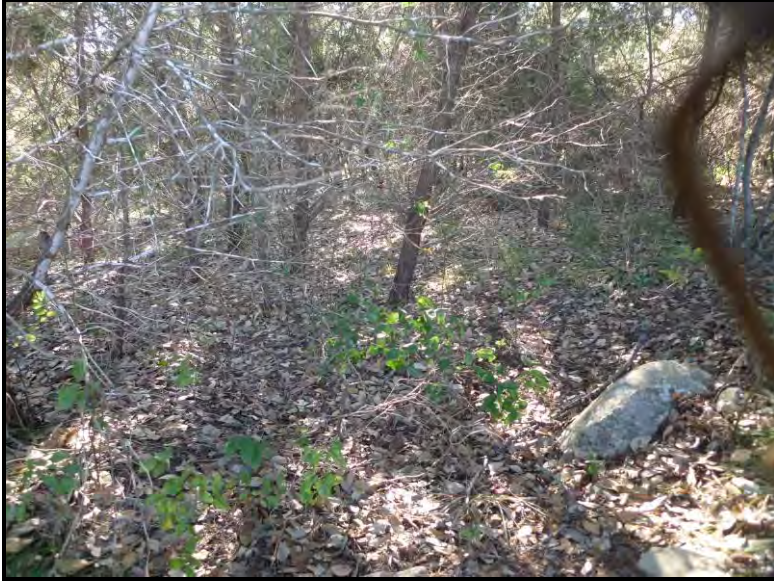
281-099, closed depression This is a probable non-karst closed depression that lies just across a fence from the ROW where ROE was denied. It is 1 m (3.3 ft) long, 0.8 m (2.6 ft) wide, and 0.2 m (0.7 ft) deep (Figure 177). It appeared to have infill of leaf litter and black, modern sediment. It may be surface disturbance associated with fence building. It was recommended for excavation, but ROE for that purpose was not obtained.

Figure 177. Overview of feature 281-099.

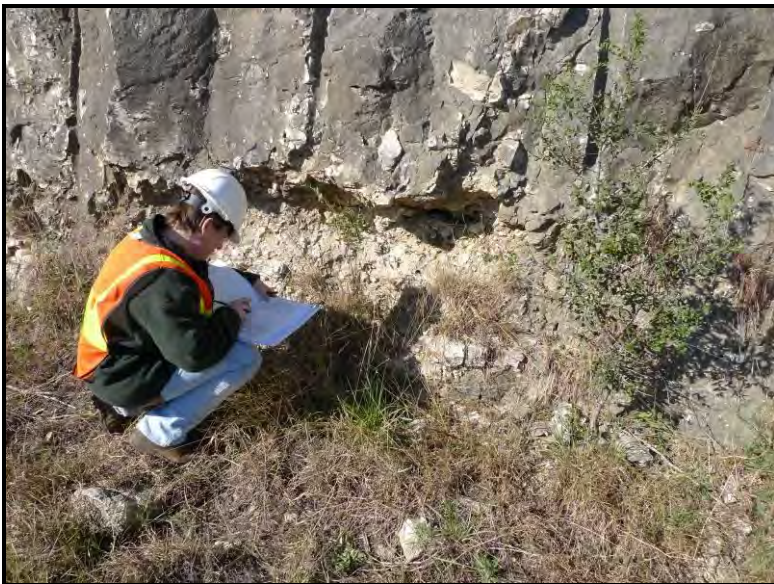
281-102, solution cavity/enlarged bedding plane This feature is located in the west road cut of US 281. The entrance to it is 0.3 m (1 ft) in diameter, and it extends into the road cut for 0.3 m (1 ft) (Figure 178). It has a coarse infill of loose rocks (Figure 179). This feature was not recommended for excavation (Table 1).

Figure 178. Overview of feature 281-102.

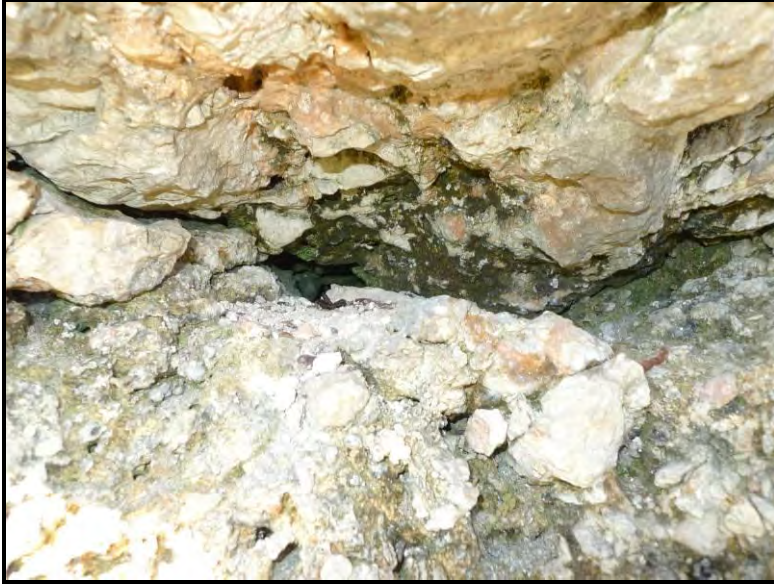
Figure 179. Interior of feature 281-102.

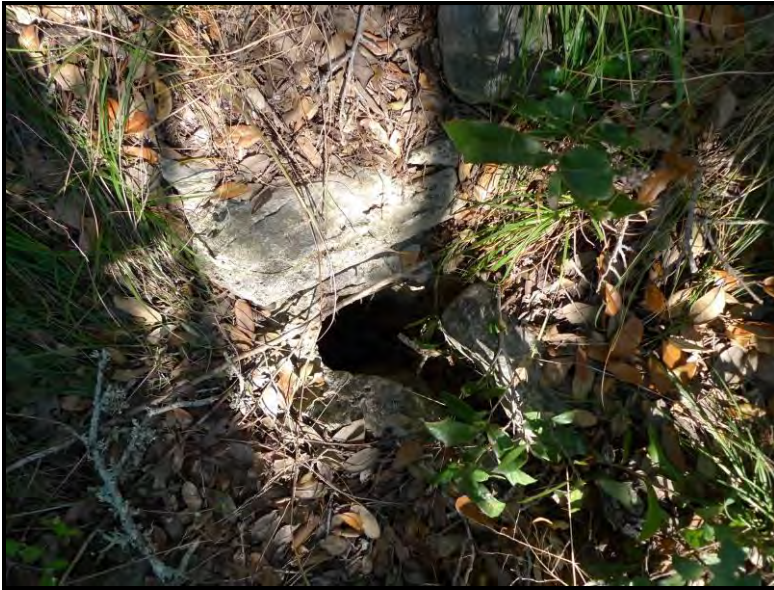
281-103, solution cavity This feature is located on private property on the west side of US 281 (Figure 180). The entrance is 0.25 m (0.8 ft) wide, 0.2 m (0.7 ft) long, and when initially assessed it dropped 0.4 m (1.3 ft) to a floor composed of organic debris and soil that was loose to a depth of loose. Preliminary excavation lowered the floor 0.1 m (0.15 ft), but more excavation would have required removal of some of the bedrock walls (Figure 181). This was recommended, but ROE for that purpose was denied.

Figure 180. Overview of feature 281-103.

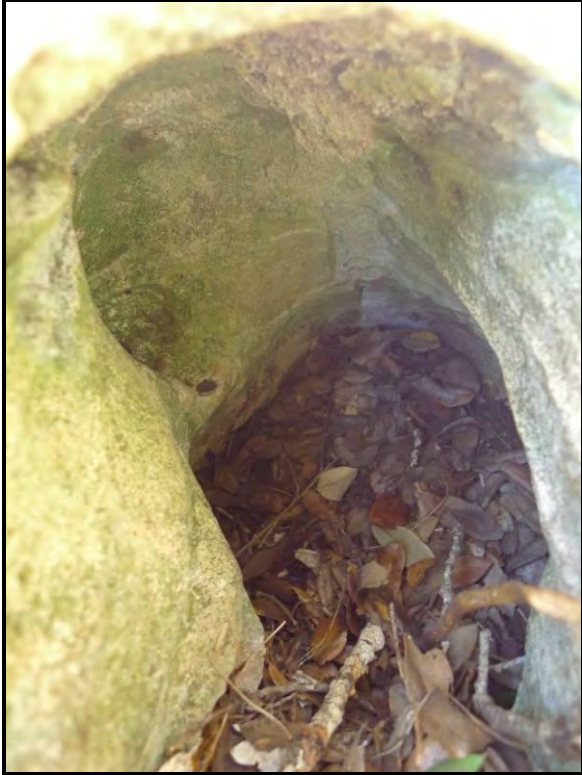
Figure 181. Interior of feature 281-103.

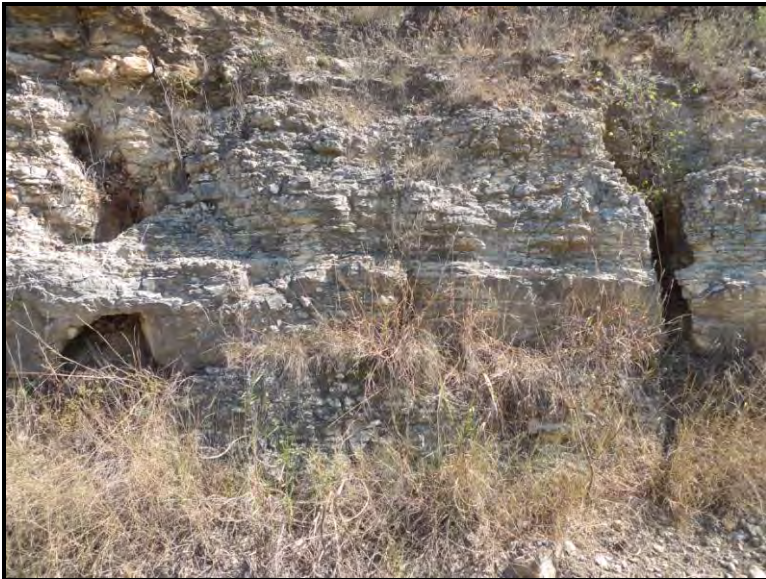
281-104, solution cavity This consists of two solution cavities in the east US 281 road cut, one of which is associated with a fracture (Figure 182). The north cavity is 0.8 m (2.6 ft) wide, 1.2 m (3.9 ft) tall, and extends into the road cut for 0.2 m (0.7 ft). The south cavity is 0.4 m (1.3 ft) wide, 1.3 m (4.3 ft) tall, and extends into the road cut for 0.7 m (2.3 ft). These contain coarse infill of rocks that is likely a consequence of road cut excavation (Figure 183). This feature was not recommended for excavation (Table 1).

Figure 182. Overview of feature 281-104.

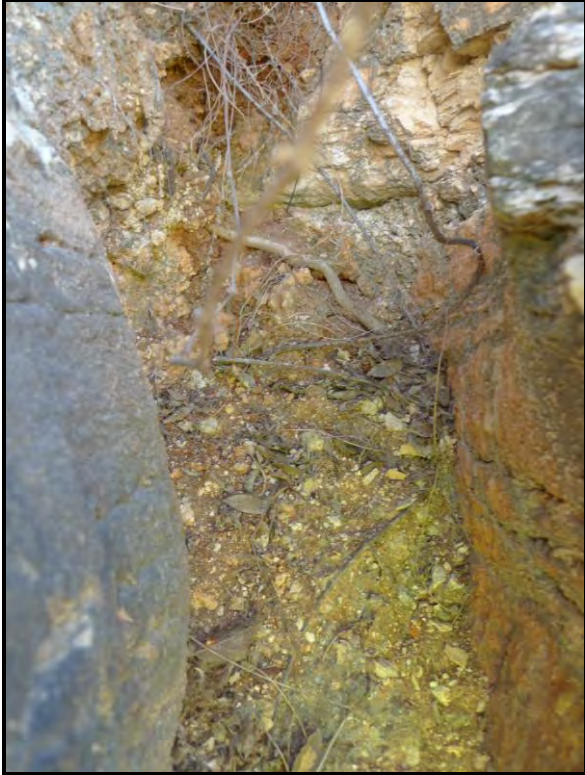
Figure 183. Interior of feature 281-104.

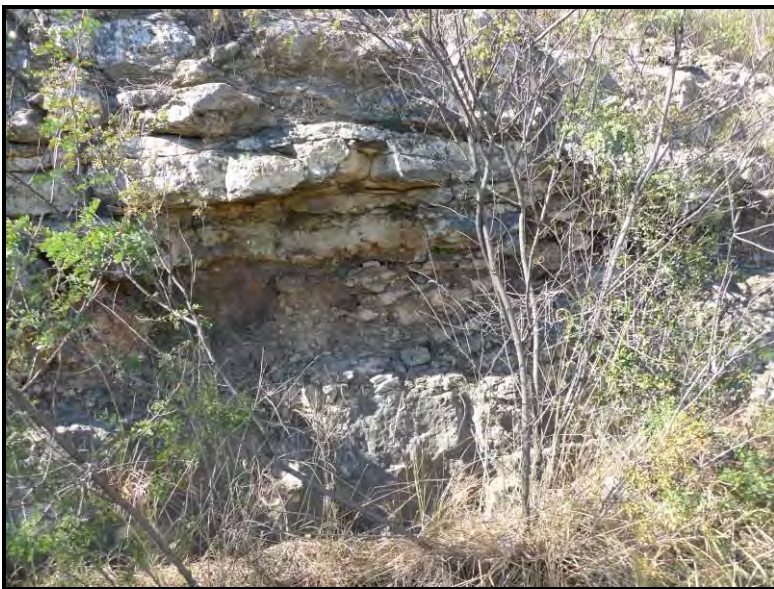
281-105, solution cavity/enlarged bedding plane This feature is located in the west road cut of US 281. The entrance that is 3 m (9.8 ft) wide, 0.7 m (2.3 ft) tall, and it extends 1 m (3.3 ft) into the road cut (Figure 184). It contains no infill material (Figure 185). This feature was not recommended for excavation (Table 1).

Figure 184. Overview of feature 281-105.

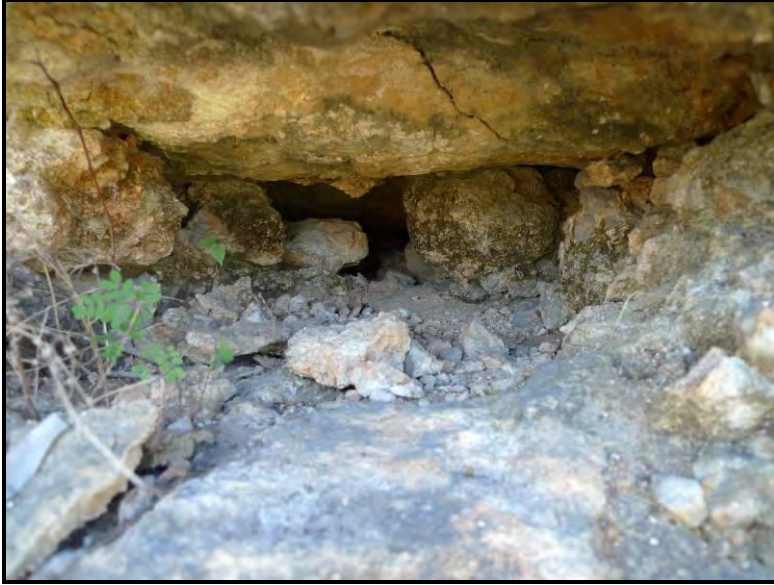
Figure 185. Interior of feature 281-105.

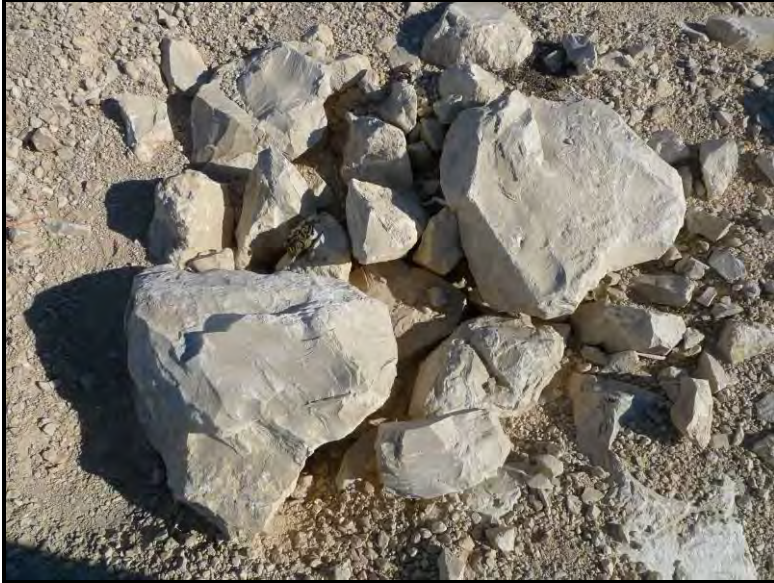
281-107, solution cavity This appears to be a solution cavity encountered during down-cutting of bedrock grade in a private property construction area (Figure 186). It is 1.5 m (4.9 ft) long, 1.3 m (4.3 ft) wide, and is 0.25 m (0.8 ft) deep. It has an infill of rocks and fine white silt (powdered bedrock) that appears to have been graded into it (Figure 187). It was recommended for excavation, but ROE for excavation purposes was not obtained.

Figure 187. Feature 281-107 appears to have been back-filled with rocks.

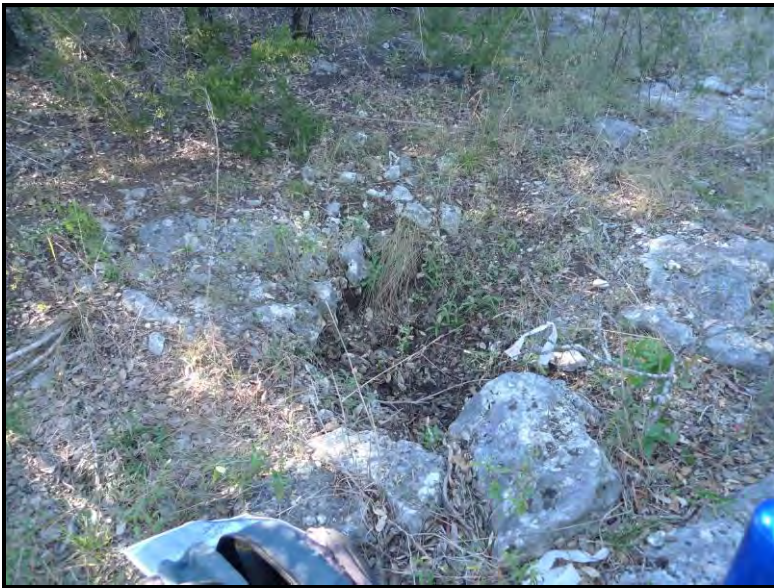
281-108, non-karst closed depression This feature is located on the east US 281 ROW in an area that was partially cleared of trees in the past. It is 0.8 m (2.6 ft) long, 0.6 m (2 ft) wide, and is 0.3 m (1 ft) deep (Figure 188). When initially assessed, it had an infill of fine, modern soil. It was excavated on 16 November 2010, which resulted in the removal of 5 cm (0.2 ft) of soil to reveal a bedrock floor. This feature is probably a result of tree removal.

Figure 188. Overview of feature 281-108.

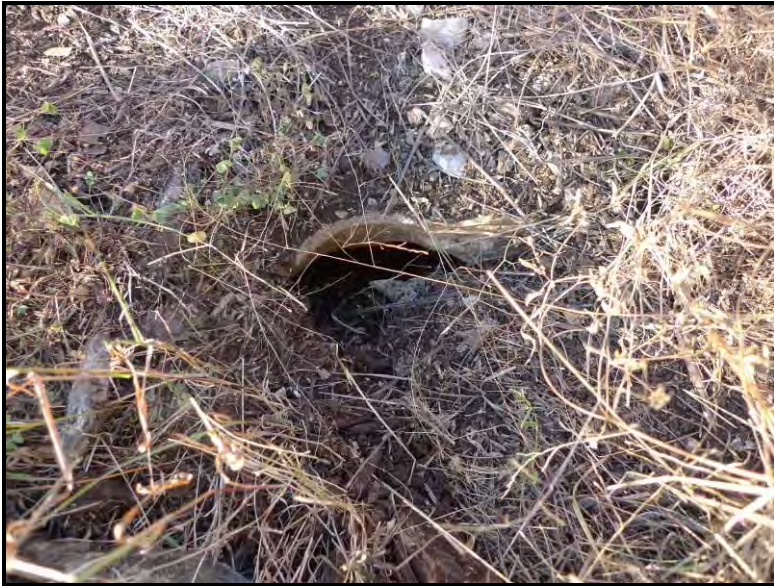
281-109, solution cavity This feature is located on private property on the west side of US 281. It consists of two 10 by 20 cm (0.3 by 0.6 ft) holes that are 1 m (3.3 ft) apart, one of them open and one plugged (Figure 189). The eastern hole drops for 0.2 m (0.7 ft) to dirt fill. This feature was recommended for excavation. No determination could be made about this feature due to lack of ROE for excavation purposes. From appearances this may

Figure 189. Overview of feature 281-109.

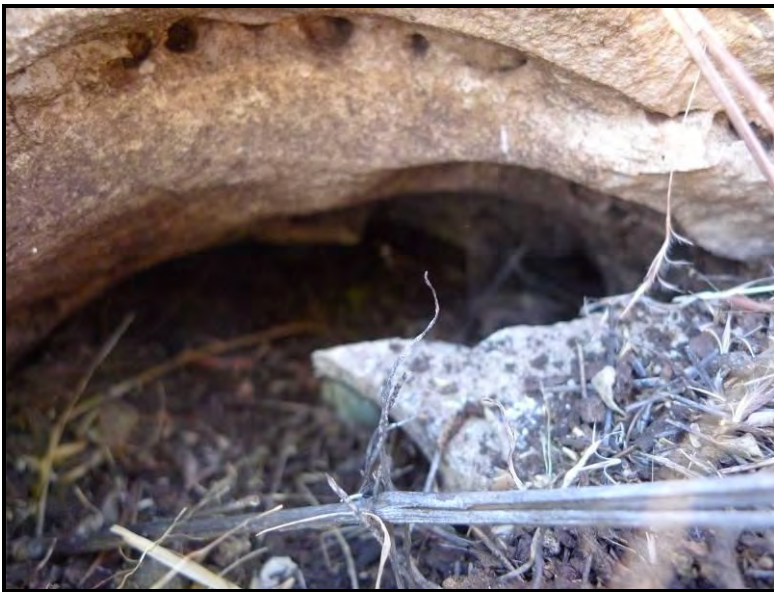
be an animal burrow under a slab of rock that has been mostly filled with soil by site grading (Figure 190).

Figure 190. Interior of feature 281-109.
